Fire Spread and Plastics Pipes

Building Research Establishment Current Paper

CI/SIB 1976	(59)	1n6	(K)	CP
				38/77

# Fire spread and plastics pipes

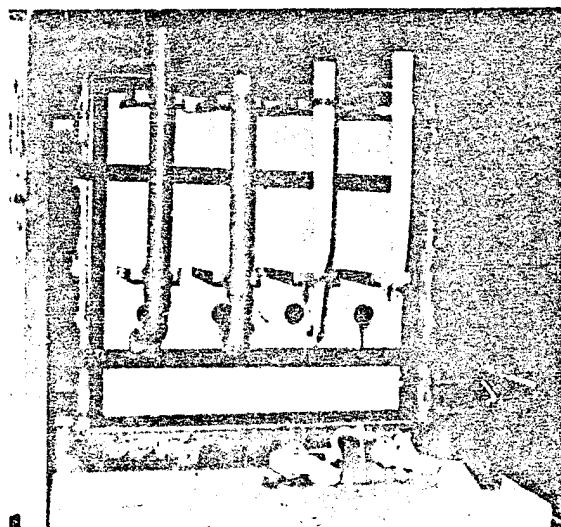
Figure 5 After test 1a

It is immediately clear that an open plastics pipe penetrating a fire resisting wall will, in the sizes investigated, fail quickly mainly due to the material becoming softened by hot gases and falling away from the wall. Time to failure is increased by increasing wall thickness and is likely to be increased by reducing pipe diameter. Under open conditions, it is unlikely that pipes of 50 mm diameter and larger of materials and pipe thickness similar to those examined can provide a satisfactory fire barrier when passing through walls of 100 mm or less. The type of support provided to the pipe through the partition will have a marked influence on its performance. Variations in pipe collapse, carbonisation and combustion may make substantial differences to the results especially with open pipes. For example, in test 1(d) the collapse of the ABS pipe provided a seal and gave a result that would not necessarily be repeatable.

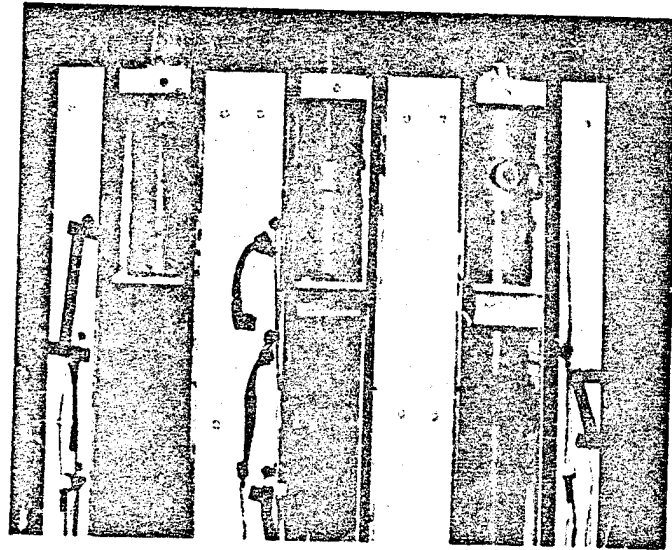
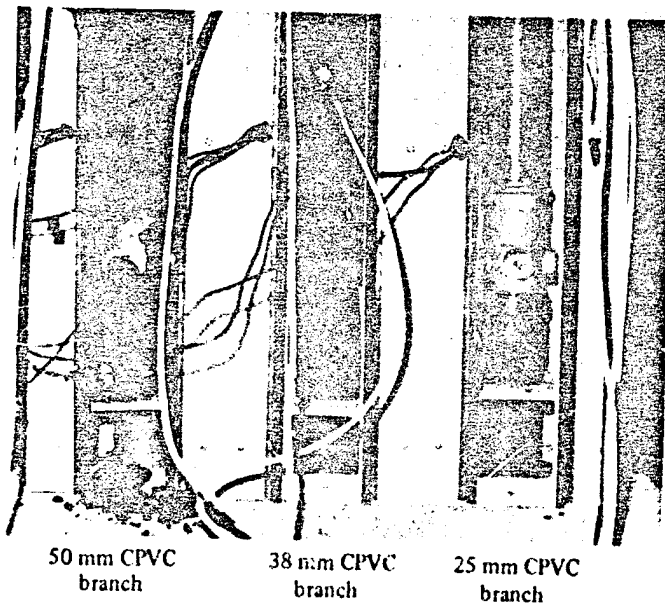
Tests 2a, 2b, 2c and 2d each consisted basically of a 50 mm, a 38 mm and a 25 mm waste pipe passing through a wall and connecting to a 100 mm stack. Damage occurred more quickly within the lower compartments penetrated by the larger pipes. This is clearly shown in Figures 16 and 17. It should be noted that the conditions shown in these figures are after 120 minutes and 100 minutes exposure respectively.

Figure 16 After test 2a. Showing variation of damage due to size of CPVC horizontal branch pipe. Duration of test: 115 min

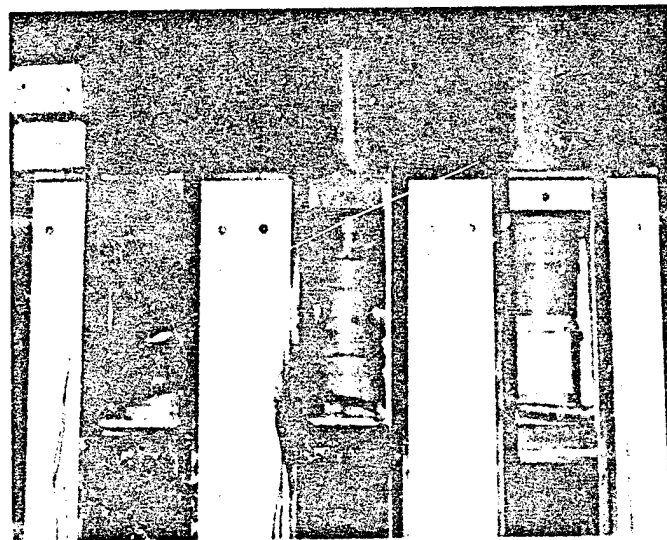
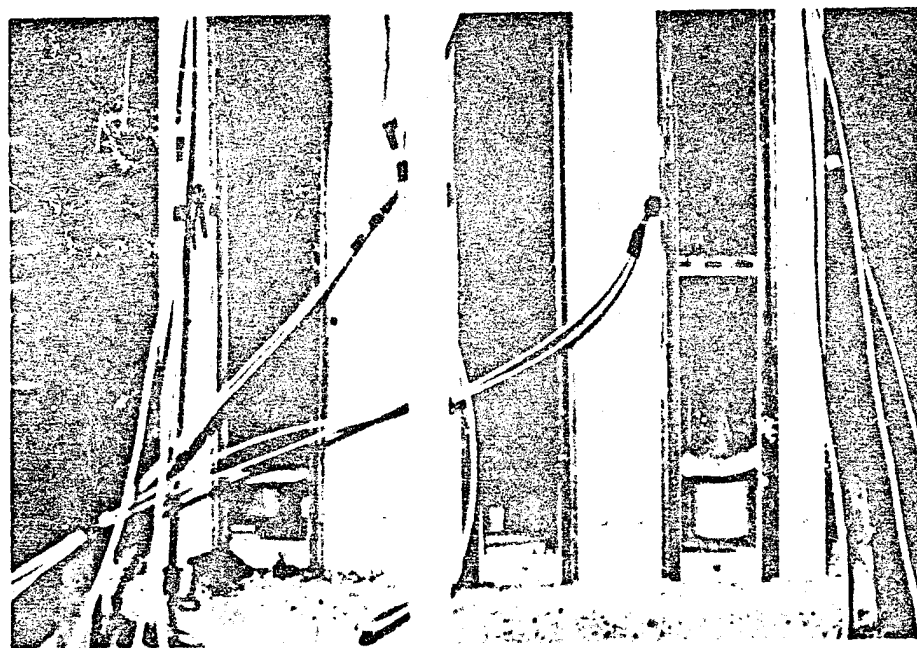
Comparison of Tests 2b and 2c suggest that the type of branch pipe material used influences the conditions within the lower compartment for an initial period but after longer periods of exposure the thickness of the exposed wall and the pipe diameter are the significant factors. The other tests although not giving a direct comparison did not contradict this statement.

Figure 17 After test 2b (75 min). Variation due to pipe size (50 mm on right, 25 mm on left) and protection given by floor stop to stack higher up clearly shown

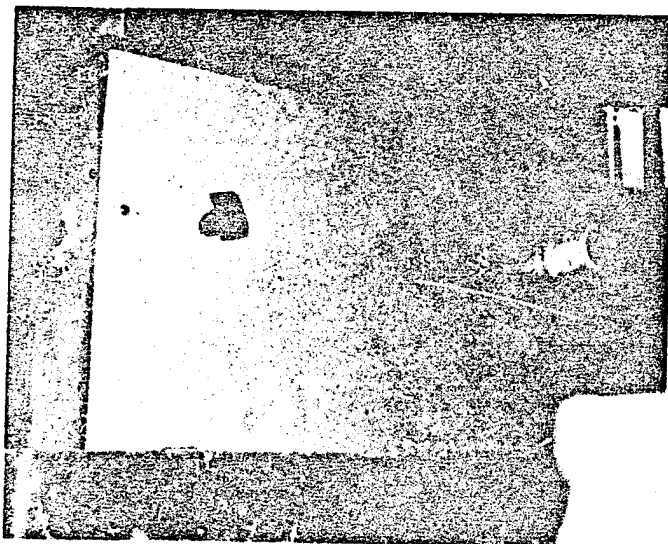
Figure 18a Front

The thickness of the wall exposed to the heating conditions was shown to have a considerable effect on the conditions within the lower compartment. Tests 2c and 2d provide a direct comparison. (Figures 17 and 18.)

Figure 18 Test 2d. Upper compartment after test (65 min). Considerable distortion inside compartment (some occurring after end of test - Figure 18b). Integrity between upper and lower compartment believed to be intact at end of test. Integrity of branch (sealed) pipes intact - Figure 18a

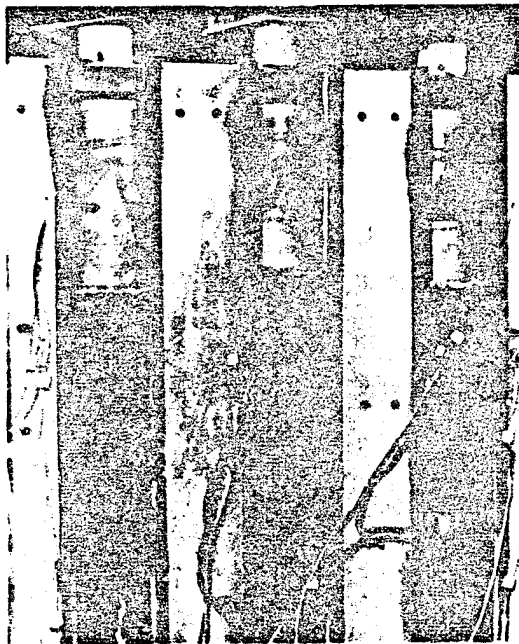
Figure 19 After test 2c. Upper compartment stacks in lower compartment completely destroyed. Stacks in upper compartment protected by floor stud (much of the distortion shown occurred well after cessation of test)

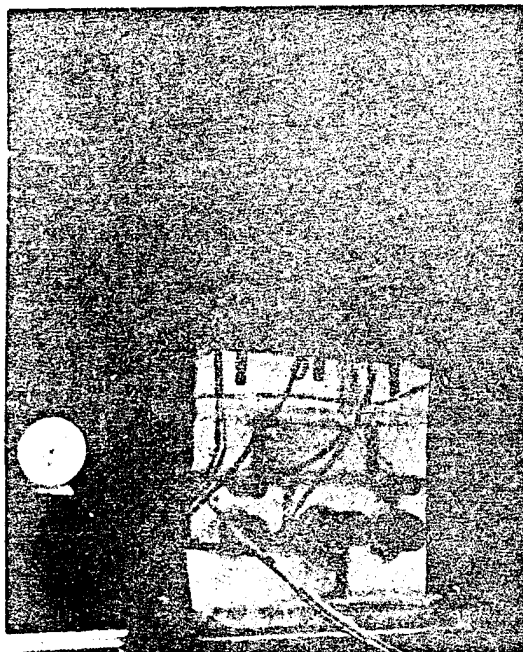
Figure 20 Test 2f. At 40 minutes

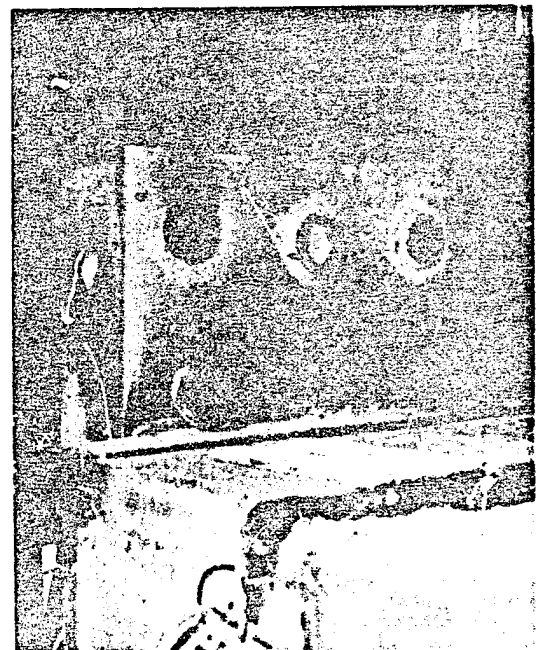
Arrangement 2f/rh was virtually the same as 2f/1h but for the exclusion of the upper fire stop. Burning in both arrangements commenced before 60 minutes. In arrangement 2f/rh, without a fire stop, the complete stack was destroyed and integrity lost from the upper compartment at 49 minutes. In the fire-stopped arrangement integrity through the fire-stop and also from the upper compartment was still intact at the end of the test (85 minutes). Figure 21.

Figure 21 After test 2f. Loss of integrity from upper compartment

when integrity was lost, (for the only time in the test series, from the upper compartment (Figure 21)). This loss of integrity seems to have occurred not solely due to the temperature in the upper compartment but also to the disturbance caused by the collapse of the stack.

Fire stops within the protected shaft are not normally required by the Regulations. The early tests in Part 2 suggested that with combustible pipes, fire stops should be provided in order to minimise spread of smoke through the building, to localise damage to the drainage system and to prevent collapse of large sections of pipework into areas in close proximity to the fire. Figures 16, 17, 18 and 19 all show the protection given to pipework higher up by the floor stop. Because of the obvious necessity for a floor stop, only one arrangement was tested without a fire stop – (2f/right hand.) The complete stack in this example collapsed at about 29 minutes. Figure 20 shows test 2f at about 40 minutes with the left hand stack intact at the upper level. Failure occurred in test 2f/rh at 49 minutes

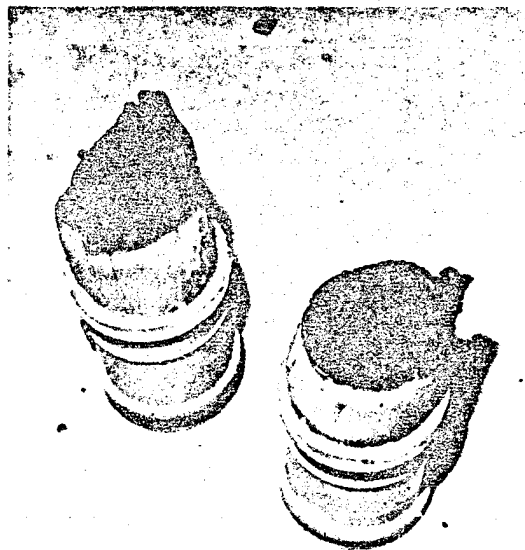
Part 1 has shown chlorinated PVC to be the best material under the type of fire test conditions investigated in that part. PVC and chlorinated PVC pipes given reasonable support (partly by the thickness of the wall) remain in position, decompose and carbonise leaving a rigid, brittle carbonaceous residue. This effect considerably assists the performance of the larger (and thicker) 100 mm pipe. Partly for this reason PVC was the only larger plastics pipe examined in Part 2. It is stressed that the comments made here and the conclusions drawn later on the use of 100 mm pipes apply only to PVC. It is believed that no other plastics material currently readily available as drainage pipework would perform as well. The carbonising effect of PVC is clearly shown on Figure 22 which shows the remains of the 100 mm PVC pipes through the 100 mm back wall of test 2f/left hand and right hand. The carboniferous

Figure 22 Horizontal branch pipes – test 2f showing rigid carbonised residue

residue will break down on prolonged exposure but will retard the penetration of fire through pipe and wall combinations.
